GFMJ-3000 24 OPzV 3000

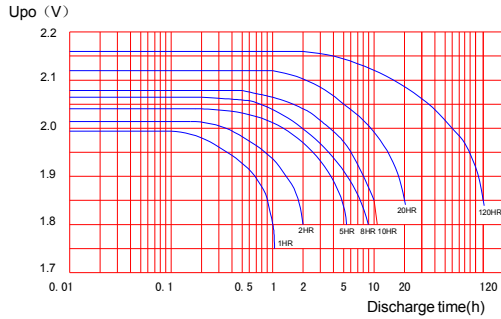
Figure 1 Discharge characteristic curve (20°C)

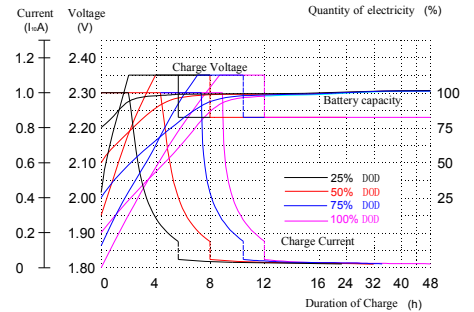
Figure 2 Constant voltage charge characteristic curve

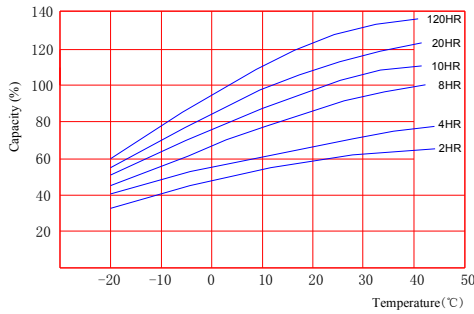
Figure 3 Relation curves between capacity and temperature

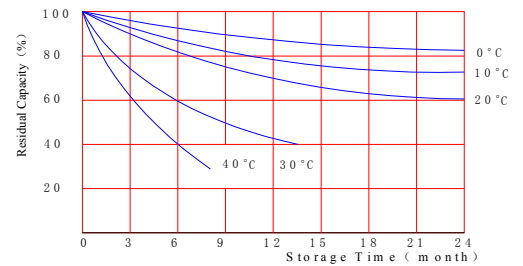
Figure 4 Self-discharge characteristic curve

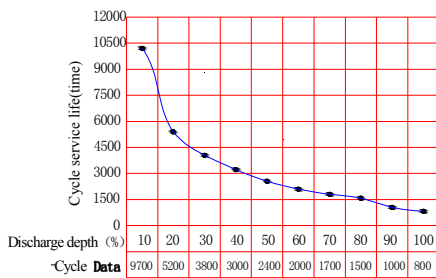
Figure 5 Relation curve between discharge depth and cycle service life

- Remark: a) test circumstances: 20-30°C, relative humidity is 50~80percent;
 b) charge mode: electricity of charge is equal to 105~115percent of discharge
 c) residual capacity is 80 percent C₁₀

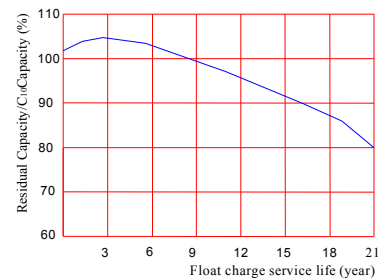
Figure 6 Relation curve between float charge service life and residual capacity
